RAILWAY INVESTIGATION REPORT
R00H0004

MAIN TRACK DERAILMENT

OTTAWA VALLEY RAILWAY / RAILAMERICA INC.

MILE 1.88, NORTH BAY SUBDIVISION

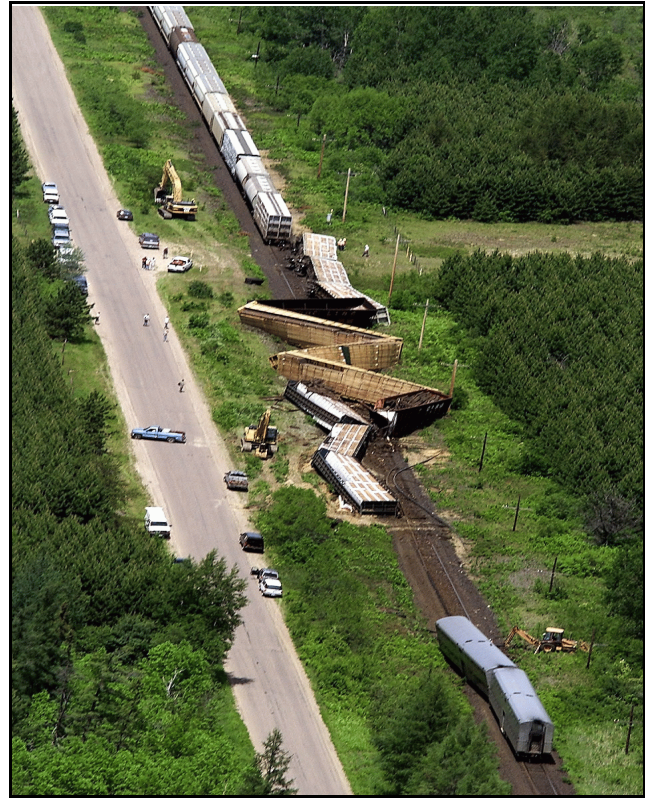
The train derailment area (see Figure 1) extended for approximately 850 feet. The two passenger cars, 8th and 9th behind the locomotive, were derailed in an upright position. The 10th, 11th and 12th cars, flat cars loaded with packaged lumber, were coupled together and lying on their sides to the south of the track. The 14th, 15th and 16th cars, centre beam flat cars loaded with lumber, and the 17th car, an empty hopper car, were upright and jack knifed on the right-of-way. The 18th, 19th and 20th cars, also flat cars loaded with packaged lumber, were lying on their sides to the north of the track. The 13th car, an open top gondola car loaded with used railway ties, although upright, had the leading end of the car torn away. Two TCPL natural gas pipelines cross about 2 m underneath the railway where the 19th and 20th cars were lying on their sides. The top corners of the cars had penetrated the ground surface to an approximate depth of 75 cm.

Figure 1. Aerial site photograph facing westward.

The rails, crossties and roadbed at Mile 1.78 were substantially displaced both longitudinally and laterally. Wheel flange marks on the web of the rail indicated that the rail had rolled over and that loss of track gauge had occurred.

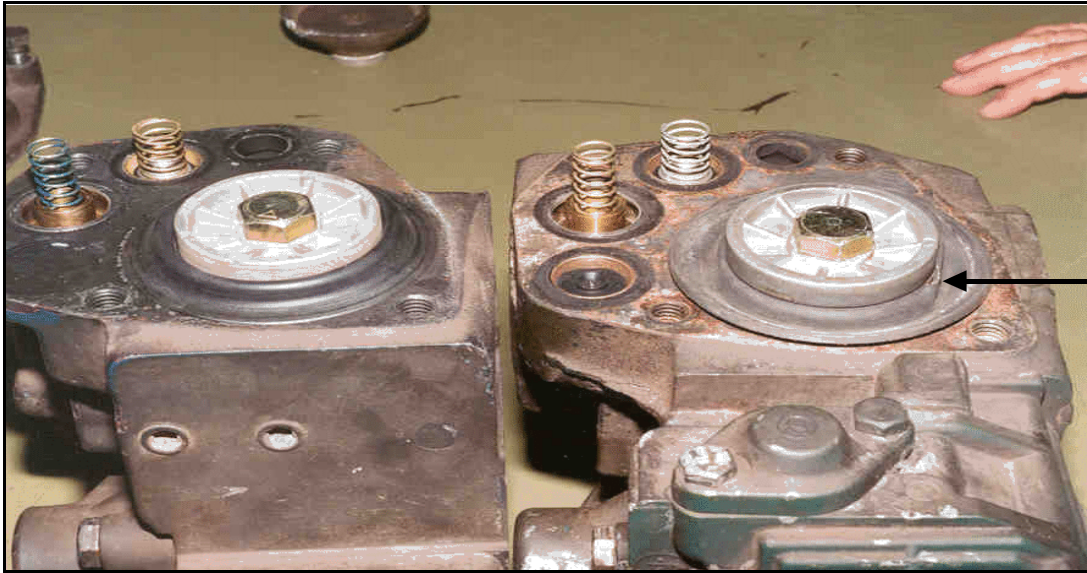
March 2000. The car passed the single car test requirements at that time. The TSB Engineering Laboratory had the ABDW emergency portion of this valve tested on an AAR-approved AB test rack at a certified air brake shop (report LP 028/01). In addition to having severe leakage problems, the emergency portion failed several requirements of the AAR-prescribed AB rack testing, including having repetitive UDEs. The diaphragm, which seals the emergency piston in its operating chamber, was ruptured approximately one inch (see Figure 2). This rupture negated the buffering effect that the diaphragm is designed to have on minor pressure fluctuations and resulted in repeated UDEs.

Figure 2 Normal diaphragm (left) compared to defective diaphragm (right).

The TSB Engineering Laboratory enlisted the services of the Quality Engineering Test Establishment (QETE) to undertake an investigation into the failure of the rubber diaphragm. The TSB supplied the emergency valve portion from this car, as well as three “in-service” emergency valve portions from sister cars, supplied by the car owner. A new diaphragm was also obtained from the air brake manufacturer for comparison purposes. The QETE report (TSB file No. LP 114/01) indicates that the diaphragms were made of neoprene rubber (polychloroprene). Neoprene rubber has a recommended shelf life of 5 to 10 years, during which the product is expected to retain its characteristics as originally specified or within allowable tolerances. The AAR Rules prescribe that newly installed diaphragms are to be within their diaphragm’s shelf life to ensure the designed strengths exist when the valves are installed on rail cars. The service life is determined by the long-term effect of factors, such as applied stresses (static and dynamic) and environmental conditions, on the physical properties of the product; i.e., reduction in tensile strength, compression set, increase in hardness, reduction in flexibility, cracking/crazing, etc. When one or several of these physical properties deteriorate below a minimum accepted level, the article is considered as having reached the end of its service life.

QETE determined that all of the “in-service” diaphragms that were analyzed were permanently deformed in either a crimped or inverted position, reducing their buffering capability and making the valves prone to UDEs. In addition, there were a significant number of creases and cracks which could also lead to failure. Analysis of the diaphragm from the 11th car determined that the tear followed a crease in the rubber coating that resulted from long-term compressive strain on the inside surface of the curve in this area. This resulted in cold flow of the rubber, and a reduction in the effective thickness at this location, predisposing the diaphragm to failure.

The results of the analysis of the emergency valve portion of the 11th car, combined with the calculations of propagation of the emergency brake application, indicate that the UDE originated at the 11th car. Material analysis of the neoprene diaphragm that failed determined that the tear followed a crease in the rubber coating that resulted from long-term compressive strain on the inside surface of the curve in this area. This resulted in cold flow of the rubber, and a reduction in the effective thickness at this location, predisposing the diaphragm to failure.
